Keep it Moving

RAY-CARROLL ELEVATOR ADDS 75% RECEIVING CAPACITY WITHOUT PAUSING OPERATIONS

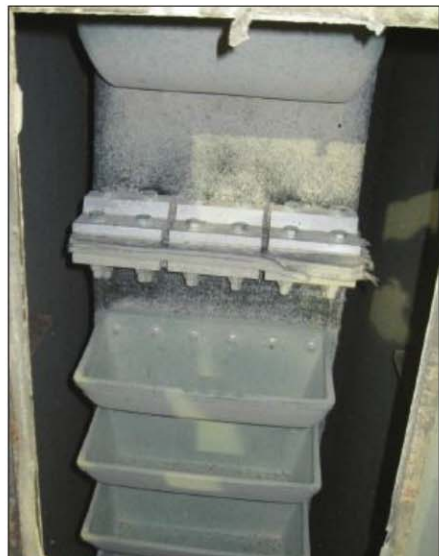
4B BC1 belt splice clamps and JUMBO™ CC-S® 16x8 low-profile buckets spaced 7.75 inches apart on 1,000-piw rubber belting. Photo courtesy of 4B Components.

4B JUMBO™ CC-S® 16x8 low-profile buckets were installed and spaced 7.75 inches apart. "We're really pleased with the new buckets," says Heddings. "The low-profile design allowed us to install the buckets closer together, so we were able to fit 624 buckets on each leg." Before, each leg held 400 buckets spaced 12 inches apart.

Eighteen-inch 1,000-piw (pounds per inch of belt width) rubber belting was supplied by **IBT** to handle the increased bucket load. According to Swisher, "not many people opt for 1,000-piw belting, because it's more expensive, but it's a great option. It's very durable and will last for years, which will save you the time and money spent maintaining or replacing standard belting."

4B BC1 belt splice clamps, designed for belts up to 1,000 piw, were installed.

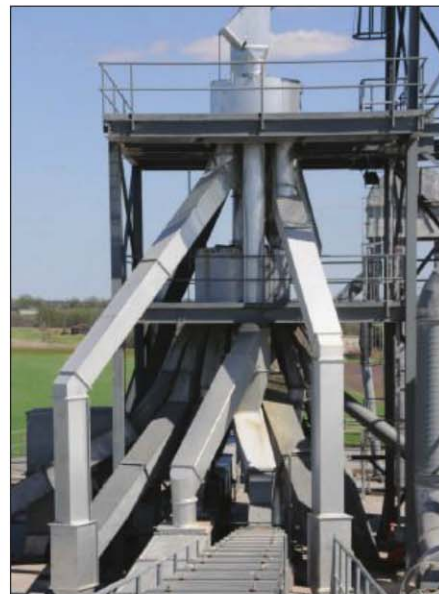
Modified Rapat distributor with enlarged spouting (middle platform) below a second, new Rapat distributor (top platform). Photo by Tucker Scharfenberg.

"We also rebuilt our distributor with custom-designed spouting by Rapat, added a new electronic controller, and converted it from dual-flow output to a single, large swing-flow spout to distribute grain to one receiving leg. We then added a second Rapat distributor to accommodate the other receiving leg.
